AquaCare

Dental Air Abrasion & Polishing Unit

Our Clinical Cases

2018 Edition

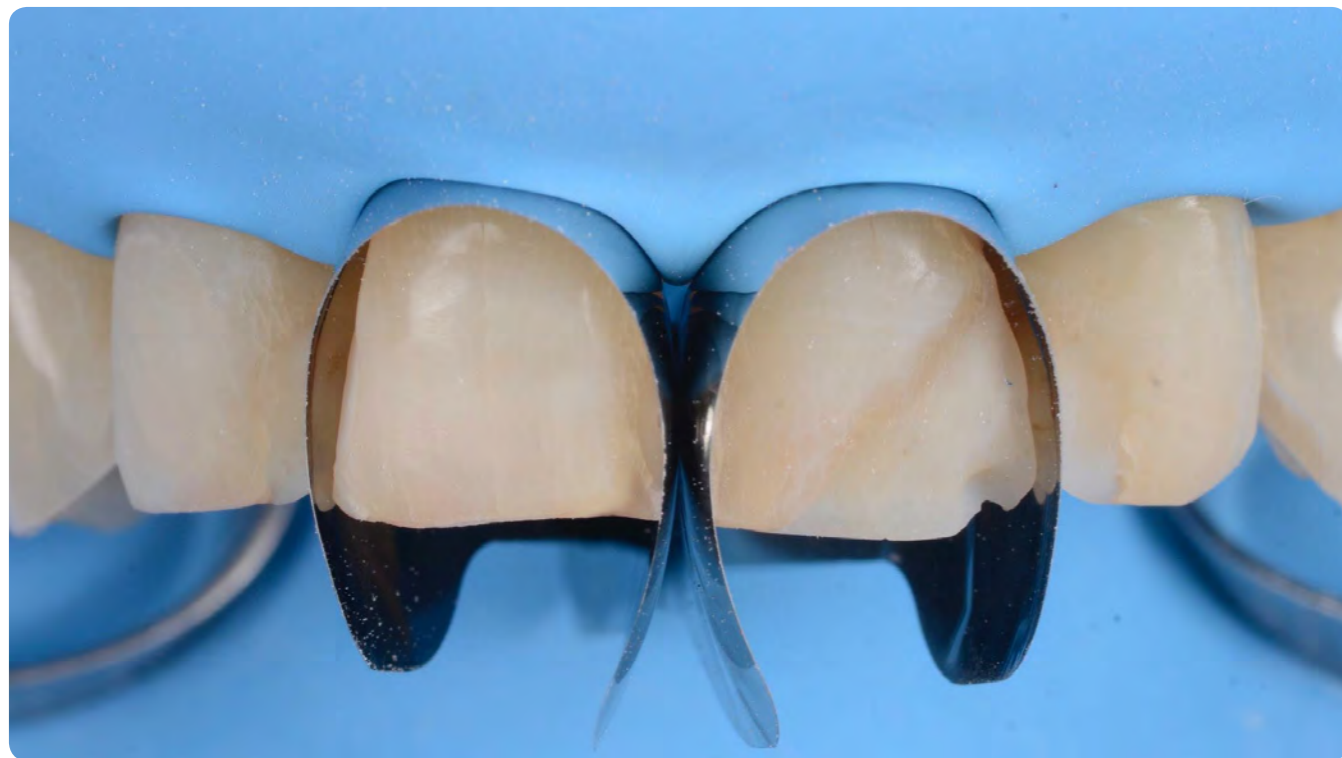
Cleaning and conditioning old composites with AquaCare 50 micron, and insertion of 2 UNICA matrices in the centrals. Matrices are held in this case by the contact point, but can be fixed either with wedges or with custom resin.

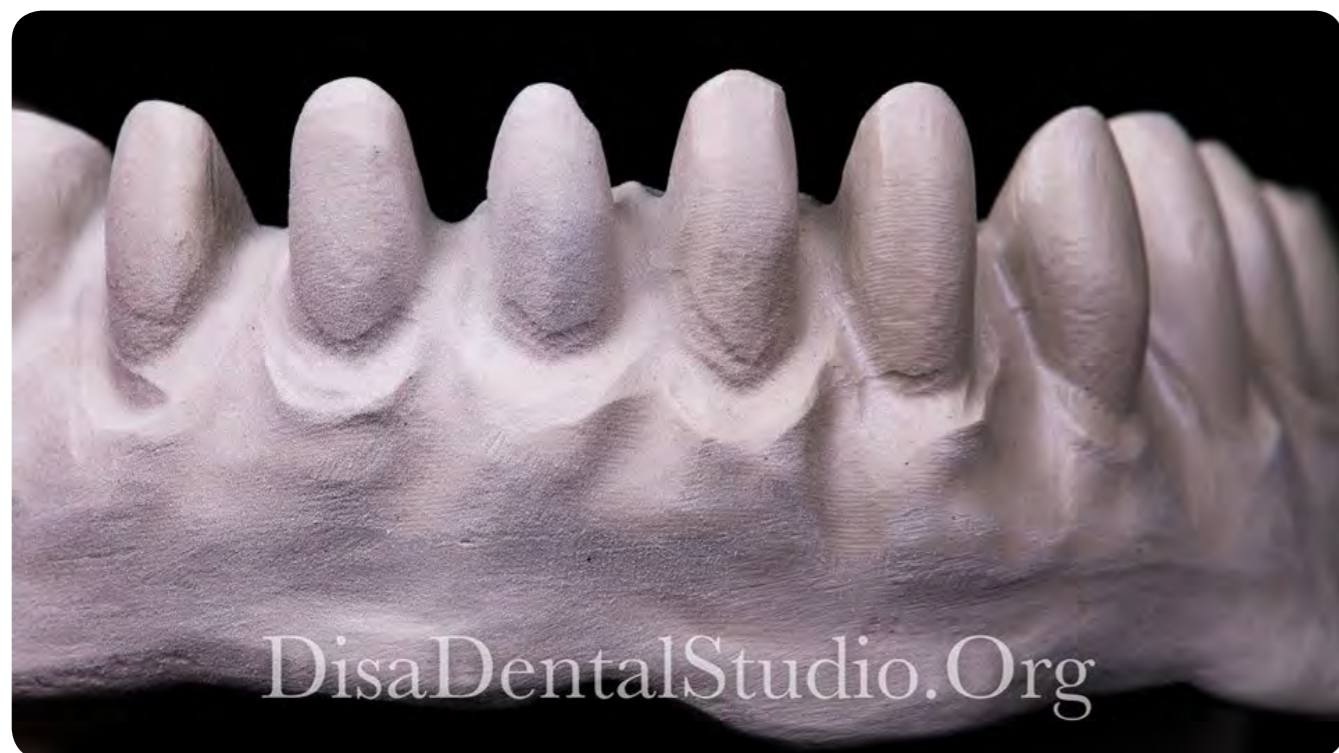
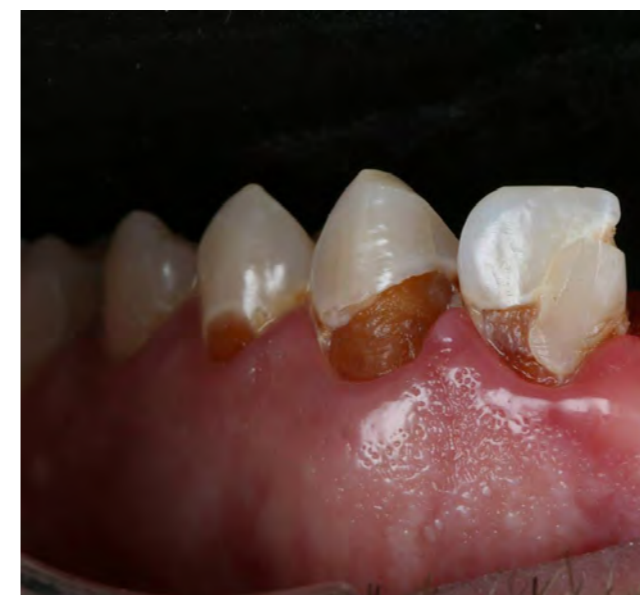
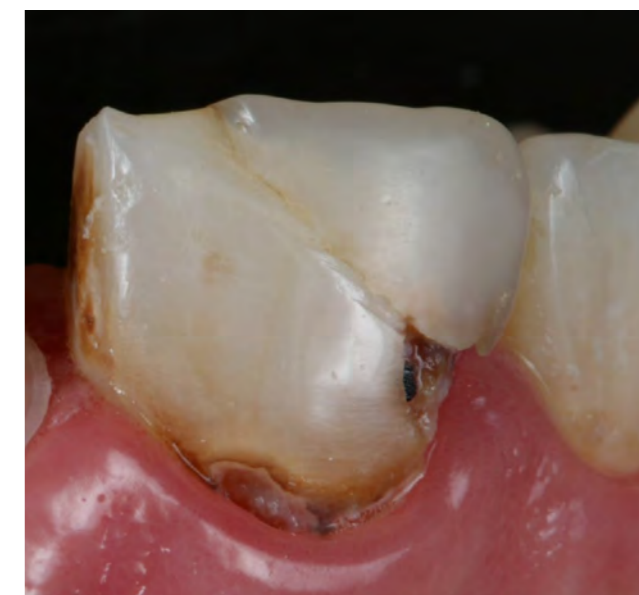
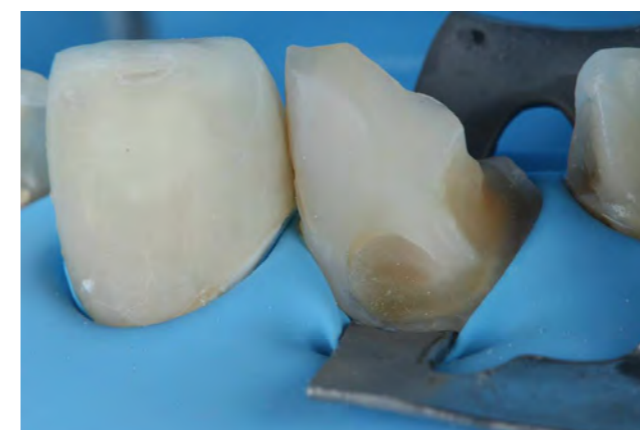
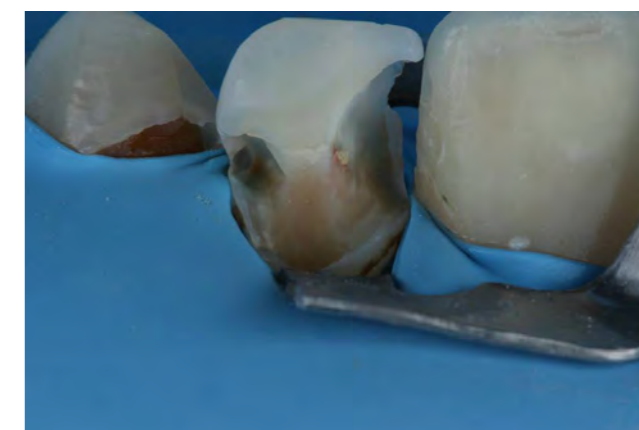
"First try with the Aquacare sand blast unit for Pekkton.
Amazing surface for bonding !!!
Can see right side is not sand blasted ... Left is sandblasted and perfect !!!"

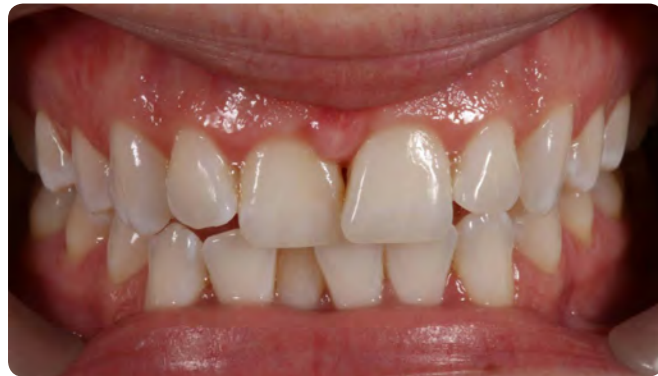
1. Initial frontal view. Patient was unhappy with the black triangle between #8 and 9 (11 and 12)

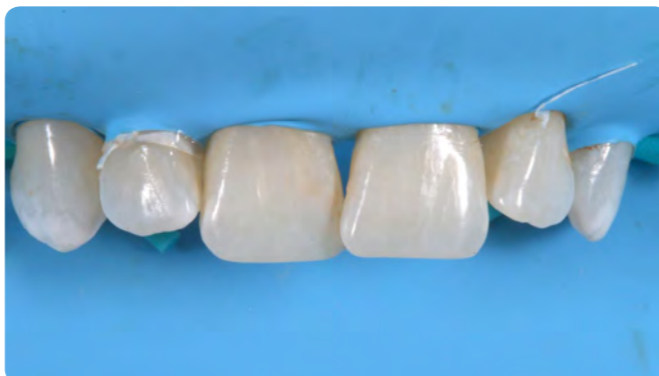
4. Rubber dam view after air abrasion. The matrices will help to retract the dam further at the operative site

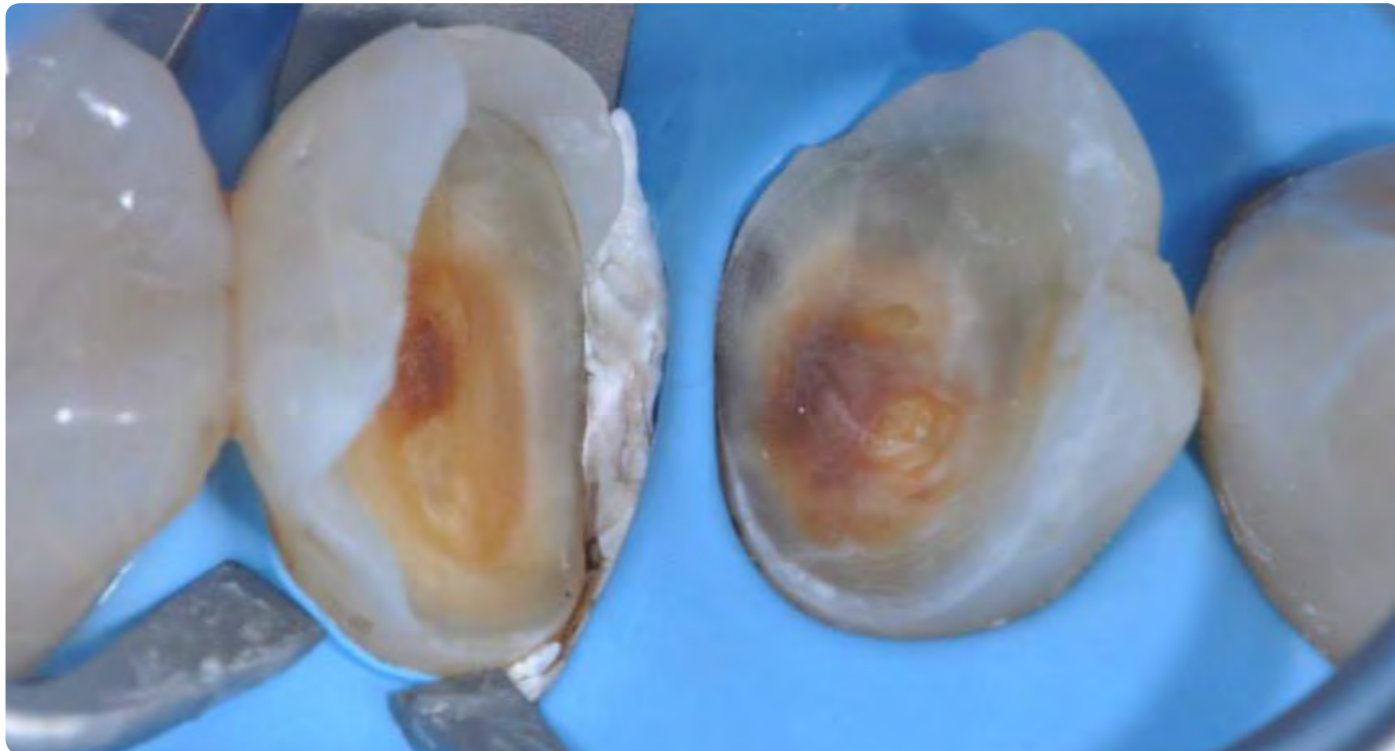
SANDBLASTING

'Used 53 micron aluminium oxide, then used electrosurgery and isolated by means of Ferrior Clamps and teflon. The image is after sandblasting and before etching.'

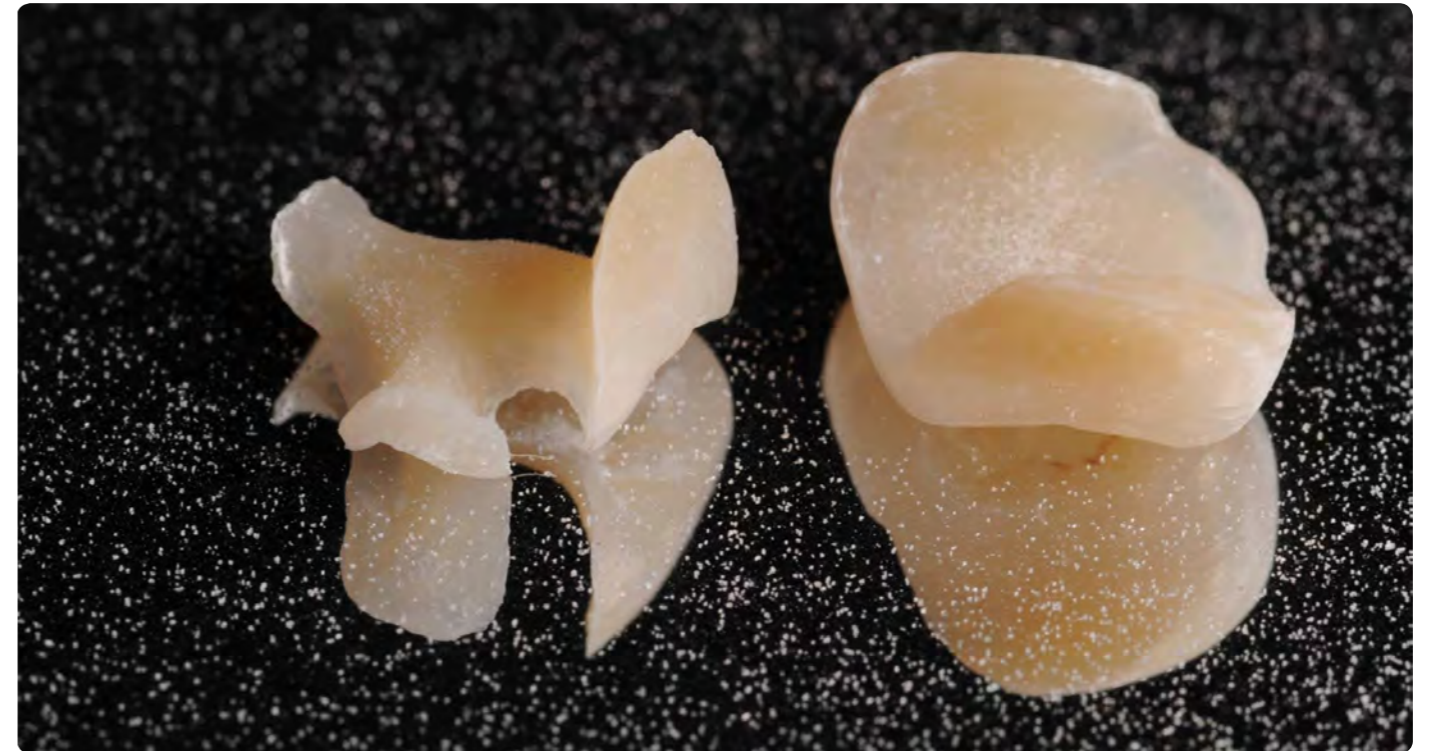
SANDBLASTING

'Two partial bonded restorations just prepared for bonding. AquaCare allows me finally to sandblast or prophylaxis inside and outside the mouth, with or without water, with the exact amount of media I want to deliver. I'm in full control now of those important procedures.'

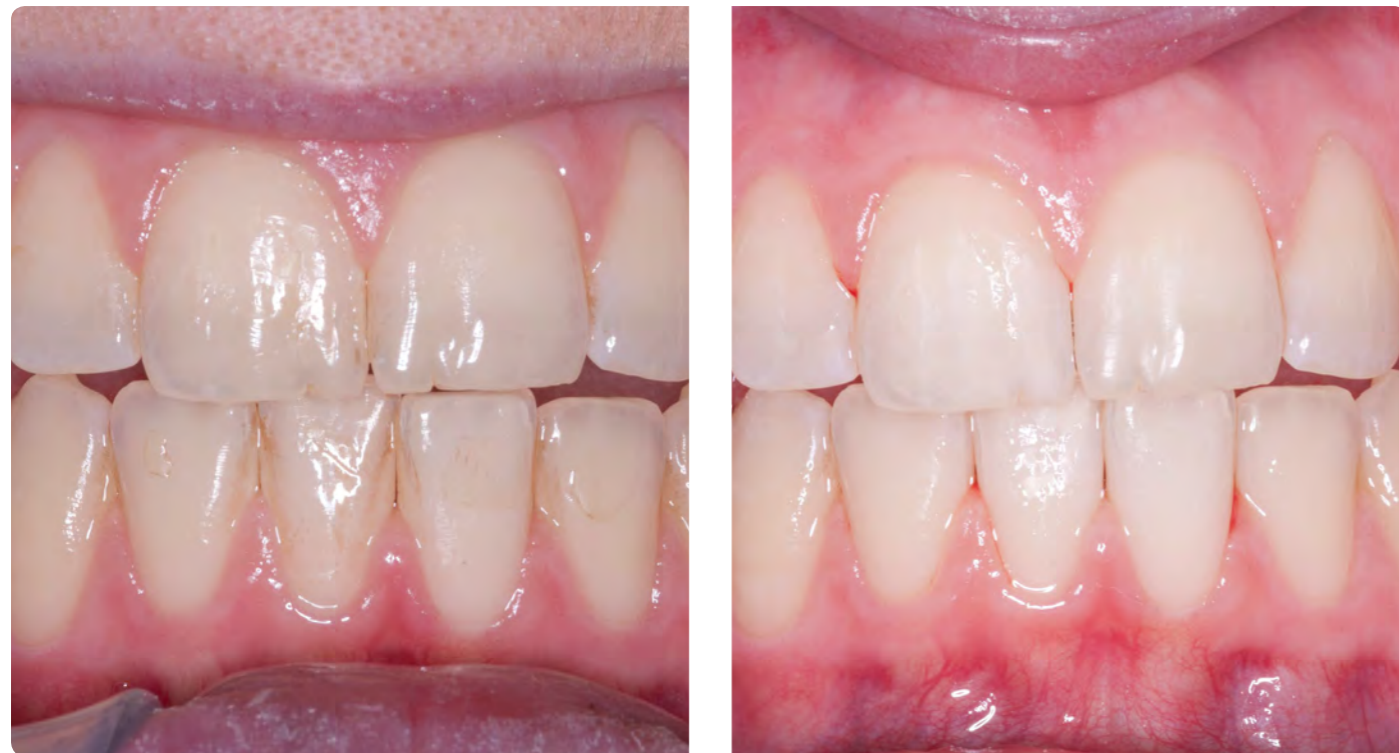
ORTHODONTIC RESIN REMOVAL

'Air polishing with a bioactive material (SYLC) at low pressure setting to remove residual orthodontic resin as an alternative to using rotary instruments.'

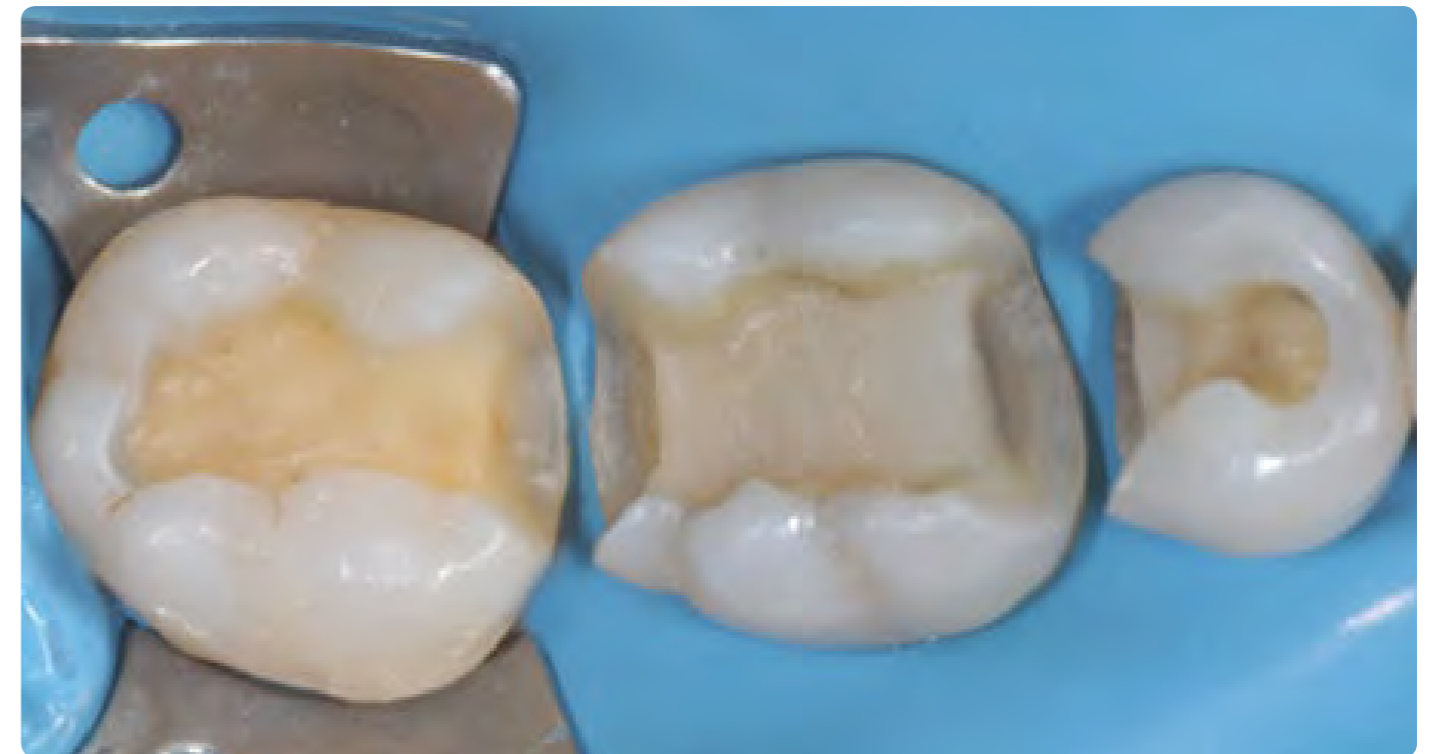
PREPARATION FOR ADHESIVE CEMENTATION

'Preparations after composite resin build-ups treated for adhesive cementation. Cleaning has been made using AquaCare Device. Powder ProCut 29 microns Al₂O₃ with LOW PRESSURE.'

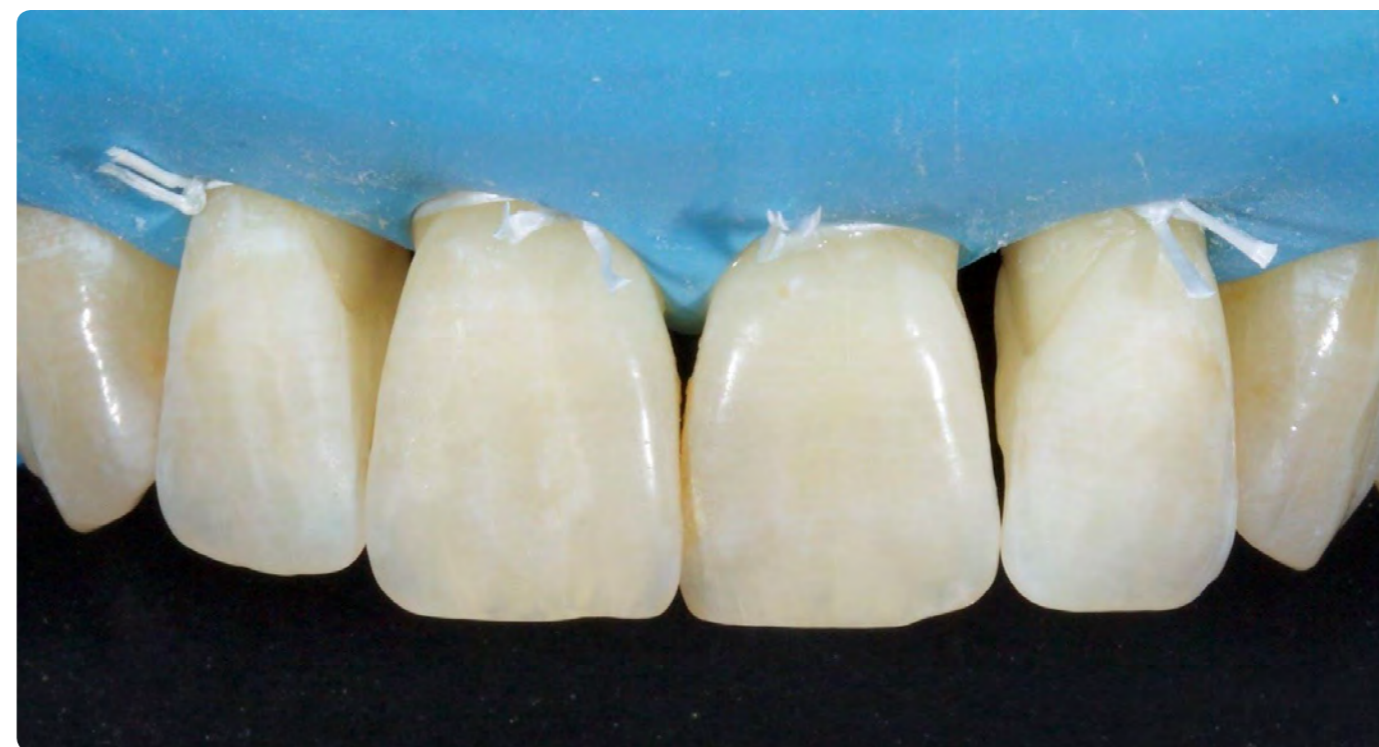
ISOLATION - PARTICLE ABRASION

'Particle abrasion with 29 micron alumina to remove aprismatic enamel and improve bond strengths prior to no prep direct bonding to close black triangles which were secondary to periodontal disease.'

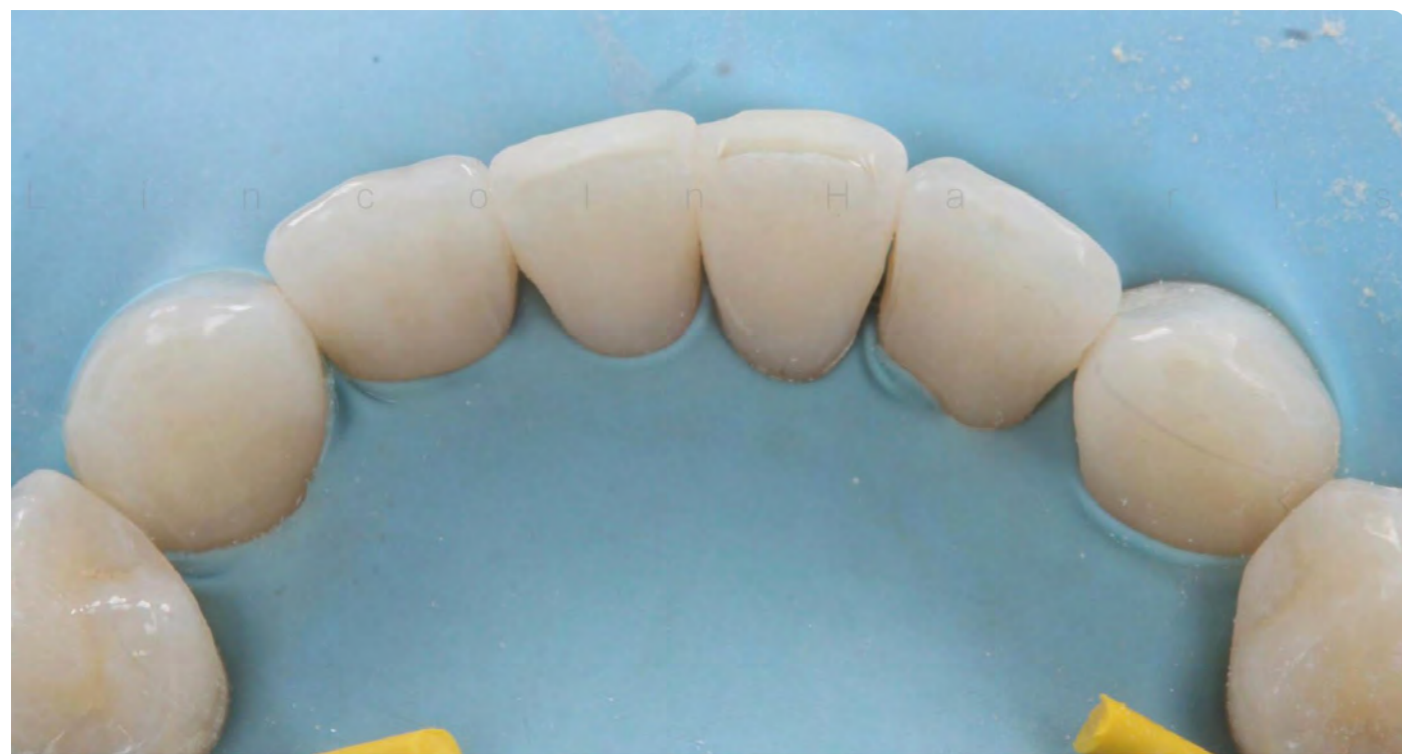
DEBONDING

Calculus removed with bicarb using Aquacut. Then moved to al oxide to remove remaining composite from previous retainer.

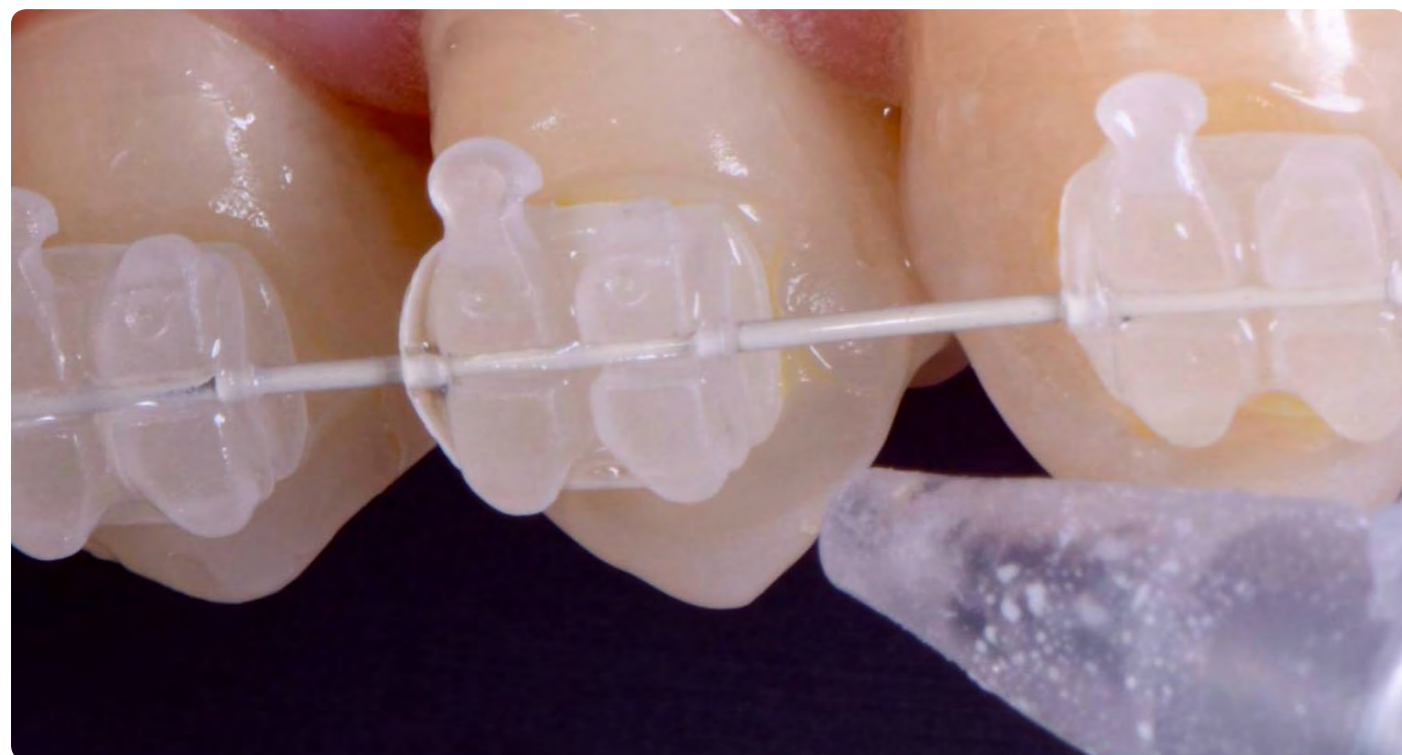
STAIN REMOVAL

'A bit of Syc on low pressure cleans up staining nicely around brackets.'

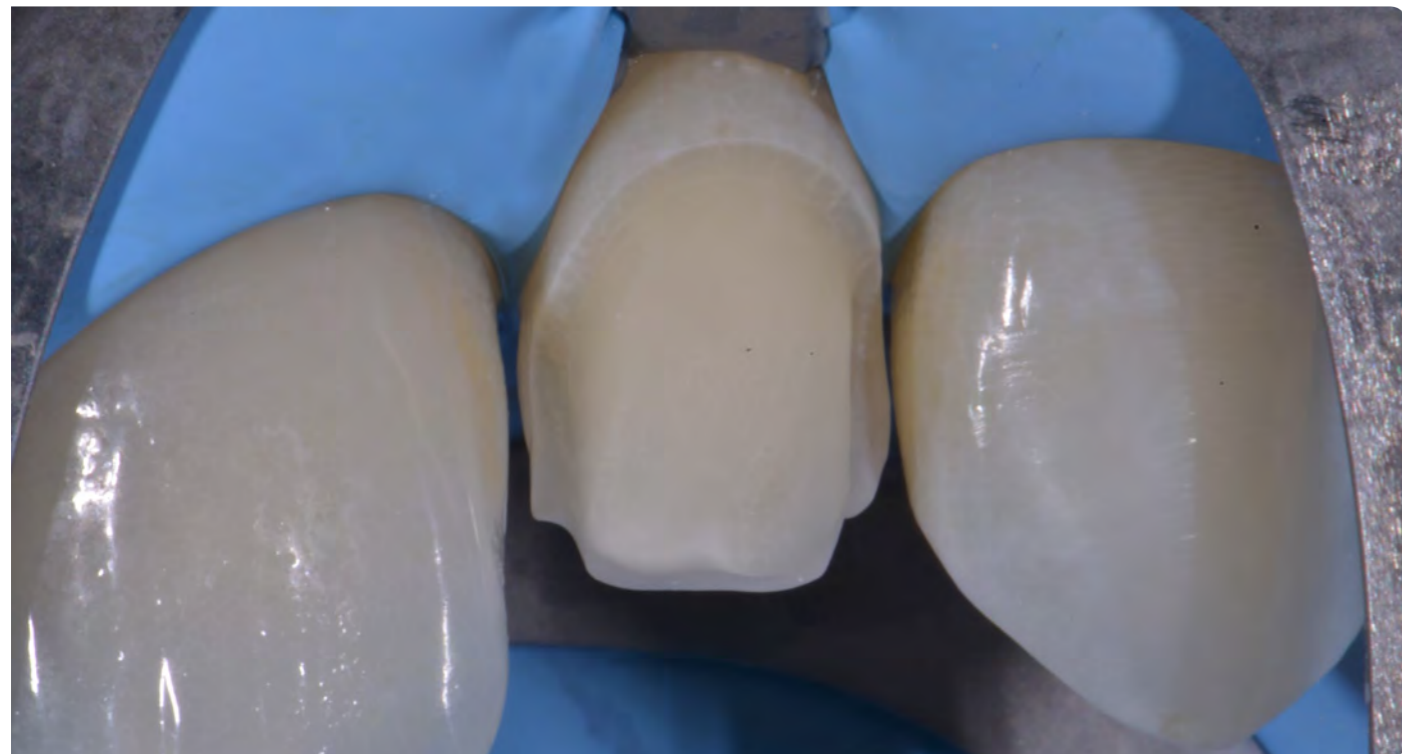
LITHIUM DISILICATE

Particle abrasion with 53 micron Aluminium Oxide to remove bonding resin used for temporaries, to clean adhesive surfaces and improve bond strengths before cementing four disilicate veneers.

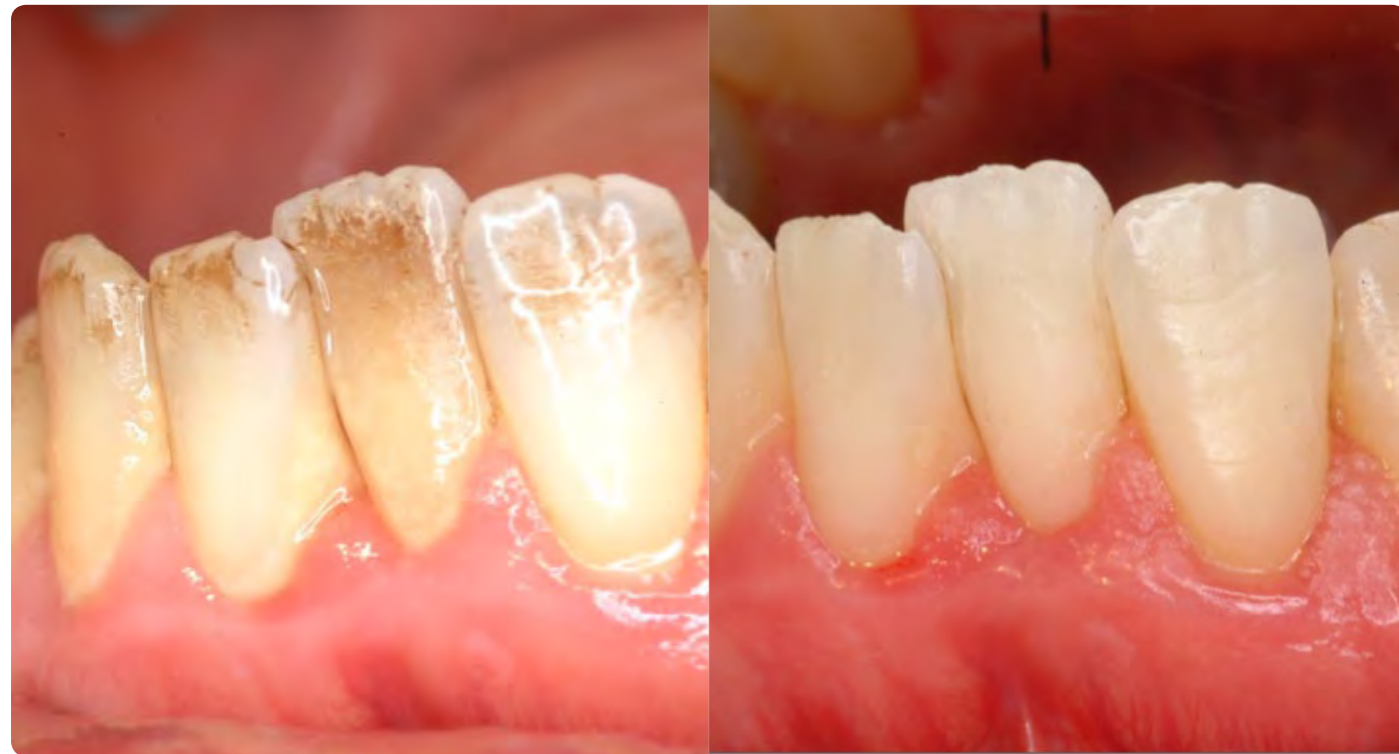
STAIN REMOVAL

'Air polishing with a sodium bicarbonate to remove staining.

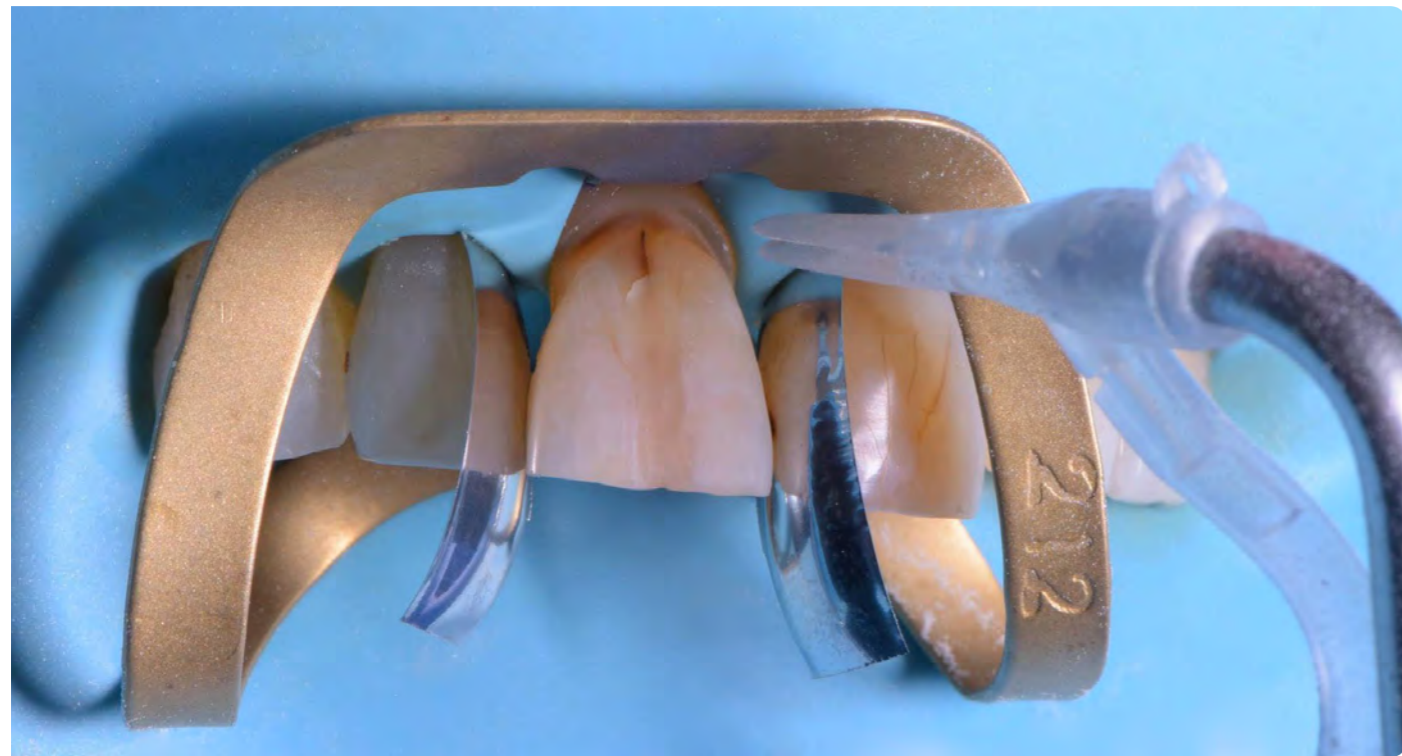
iTIP

A stable 212 rubber dam clamp with iTip cleaning

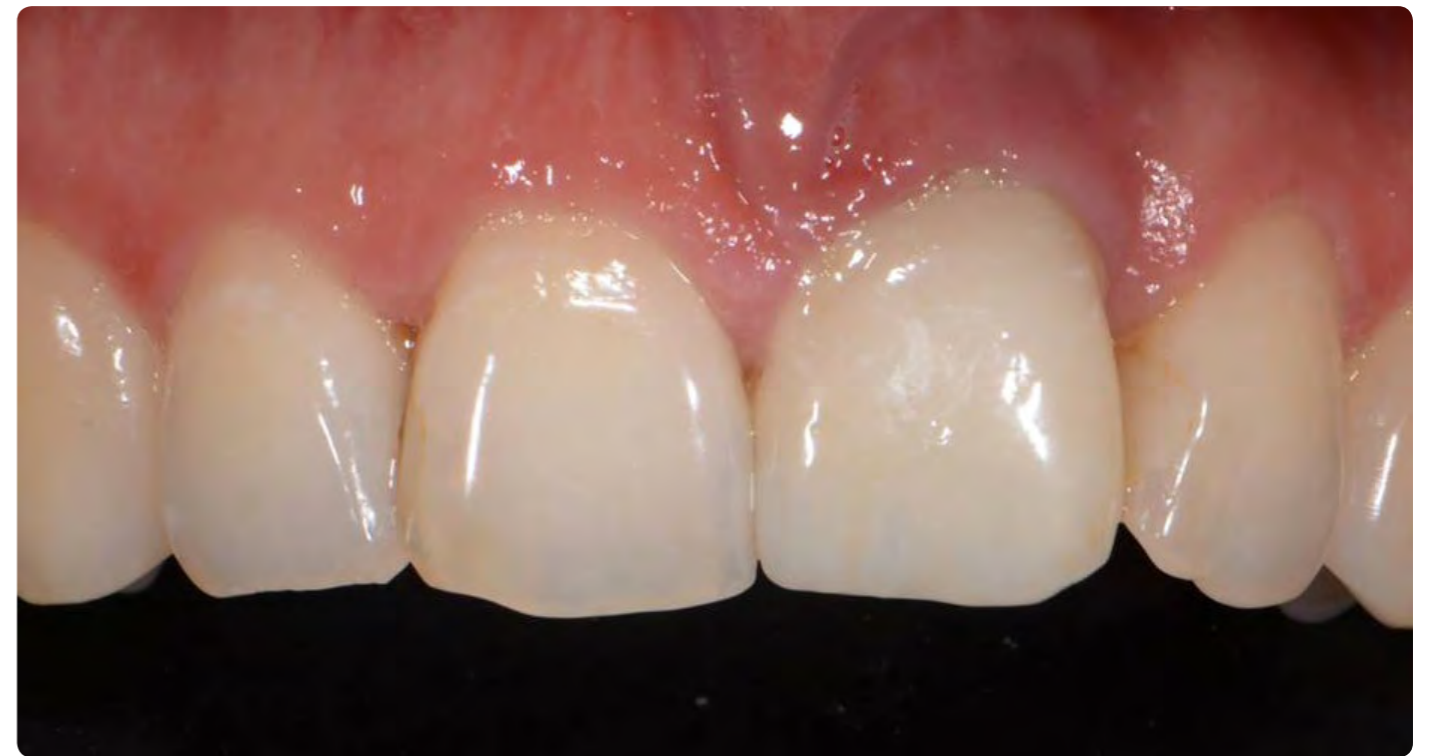
Peri-implant mucositis / early peri-implantitis on 21 is present.

This implant is 6 years old. There is bleeding and suppuration.

Minor bone loss present that occurred in a year.

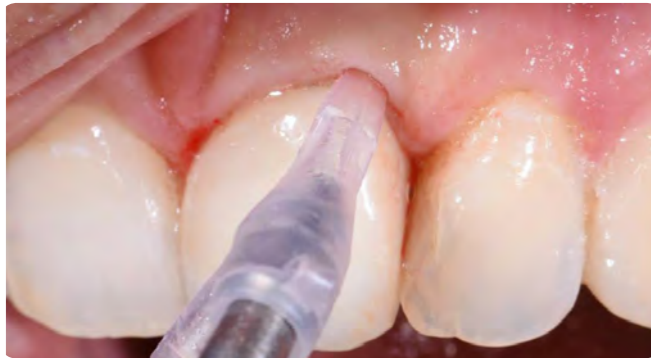
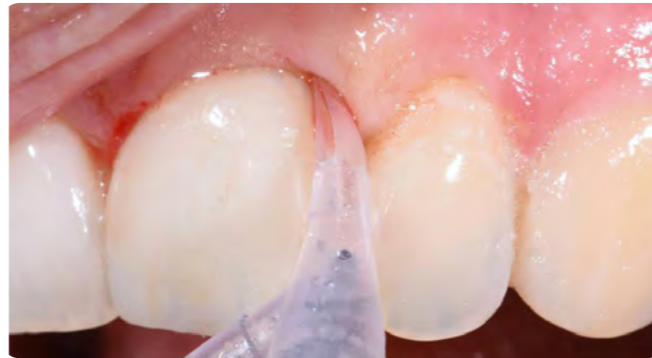
Peri-implant mucositis

The issues come and go for the last year or so. Periodontist has been managing this and the perio but a sudden flare up has come on the 21. This is a new tip that was sent by Veloplex to try on their machine for inter proximal cleaning, and I realised it would fit in this pocket.

Used with sodium bicarbonate to flush out the area. This was then flushed with Chlorhexidine, flushed again with sodium, and one last CHX intrasulcular.
